1190400006 - Madison Co.
RCRA
Reilly Tar - PERMITS

DATE: APR 15 1988
SUBJECT: RCRA Facility Assessment
Reilly Tar Chemical Corporation, Granite City, Illinois

INTRODUCTION

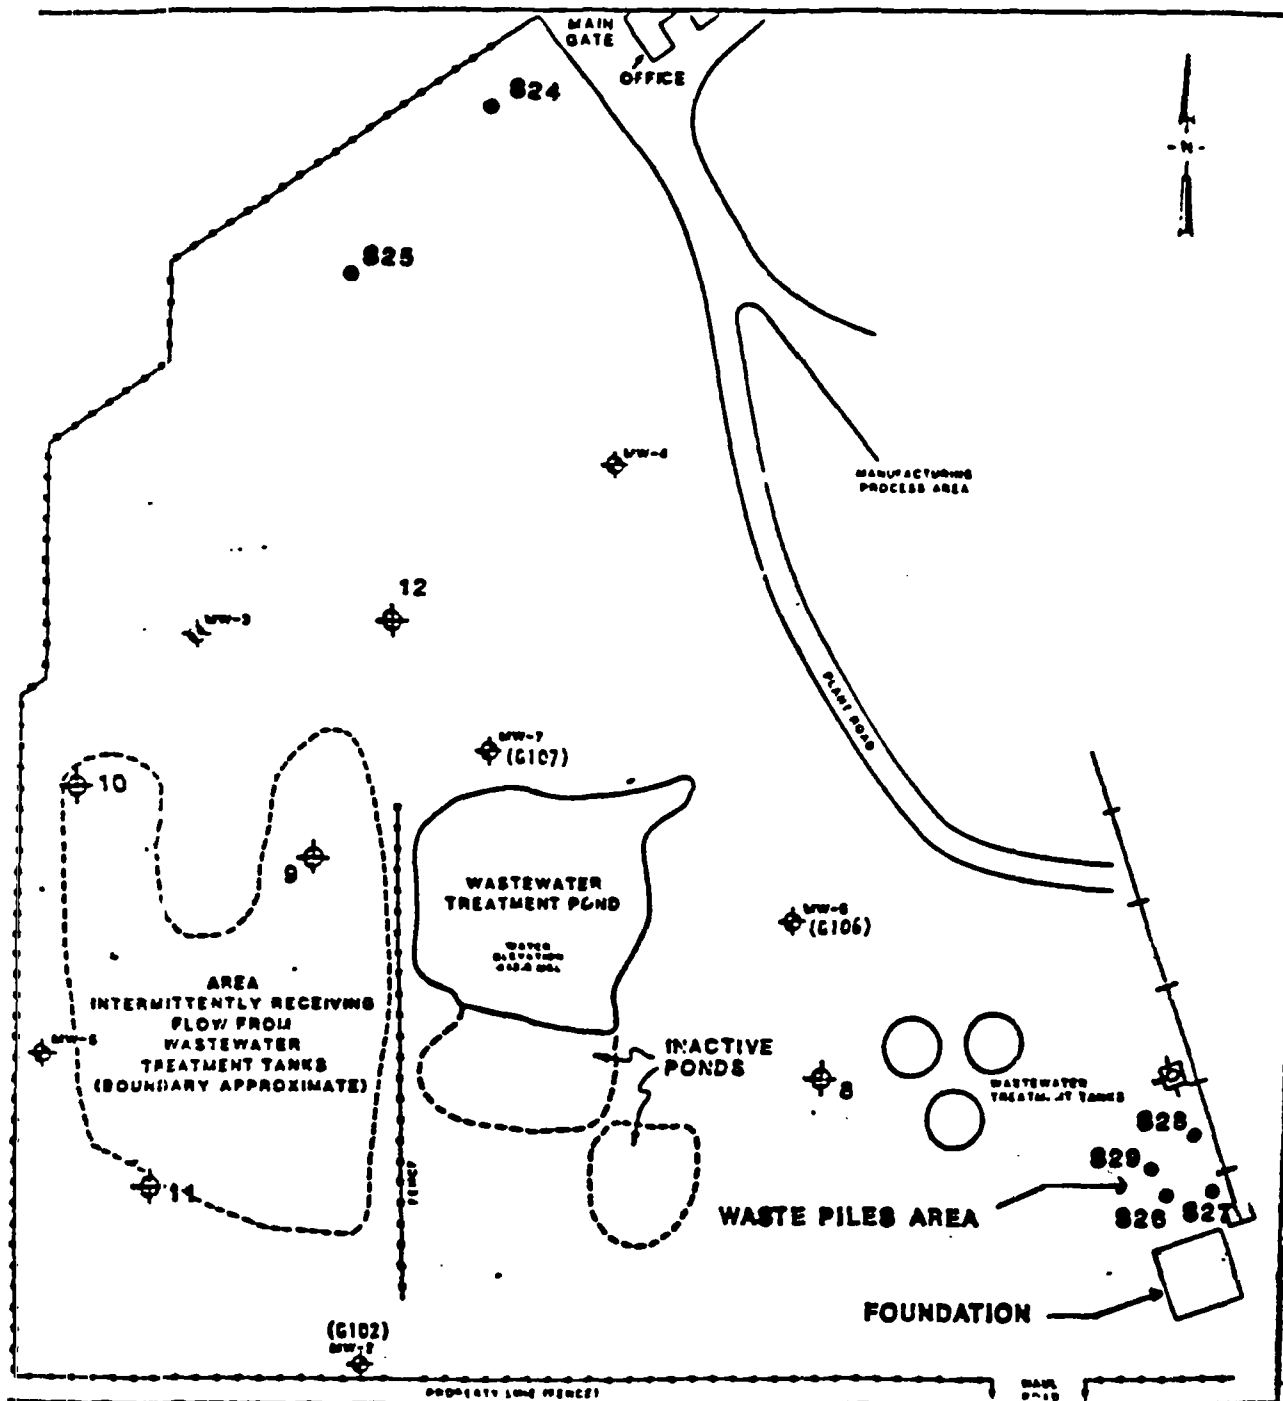
FIGURE 2 SAMPLE LOCATIONS

The following table lists the hazardous constituents listed in Appendix VIII of 40 CFR Part 261 which were specifically identified in the Solid Waste Piles Area. Figure 2 attached to this report shows the sampling locations.

Appendix VIII Constituent, mg/kg	Waste Pile Area Samples				Background Samples	
	S26	S27	S28	S29	S24	S25
Cadmium					7.8	
Lead			116			
1,1,1-trichlorethane	0.017					
Toluene	0.007					
Fluoranthene	74		160	32		
Benzo(a)Anthracene	41		47			
Benzo(b)Fluoranthene	49		46			
Benzo(a)Pyrene	43		33			
Naphthalene				150

All of the organic compounds listed above were detected at concentrations two times greater than background sample S25. Based on the analyses results, sample S25 appears less affected by the activities at the facility and more representative of the natural soil conditions in the area. Background sample S25 contained no metal compounds exceeding the maximum concentration for typical soils. (See March 1988, M&E Data Evaluation Report, Contract No.68-01-7351).
